# *Hurricane Sandy*

# Hurricane Sandy Timeline

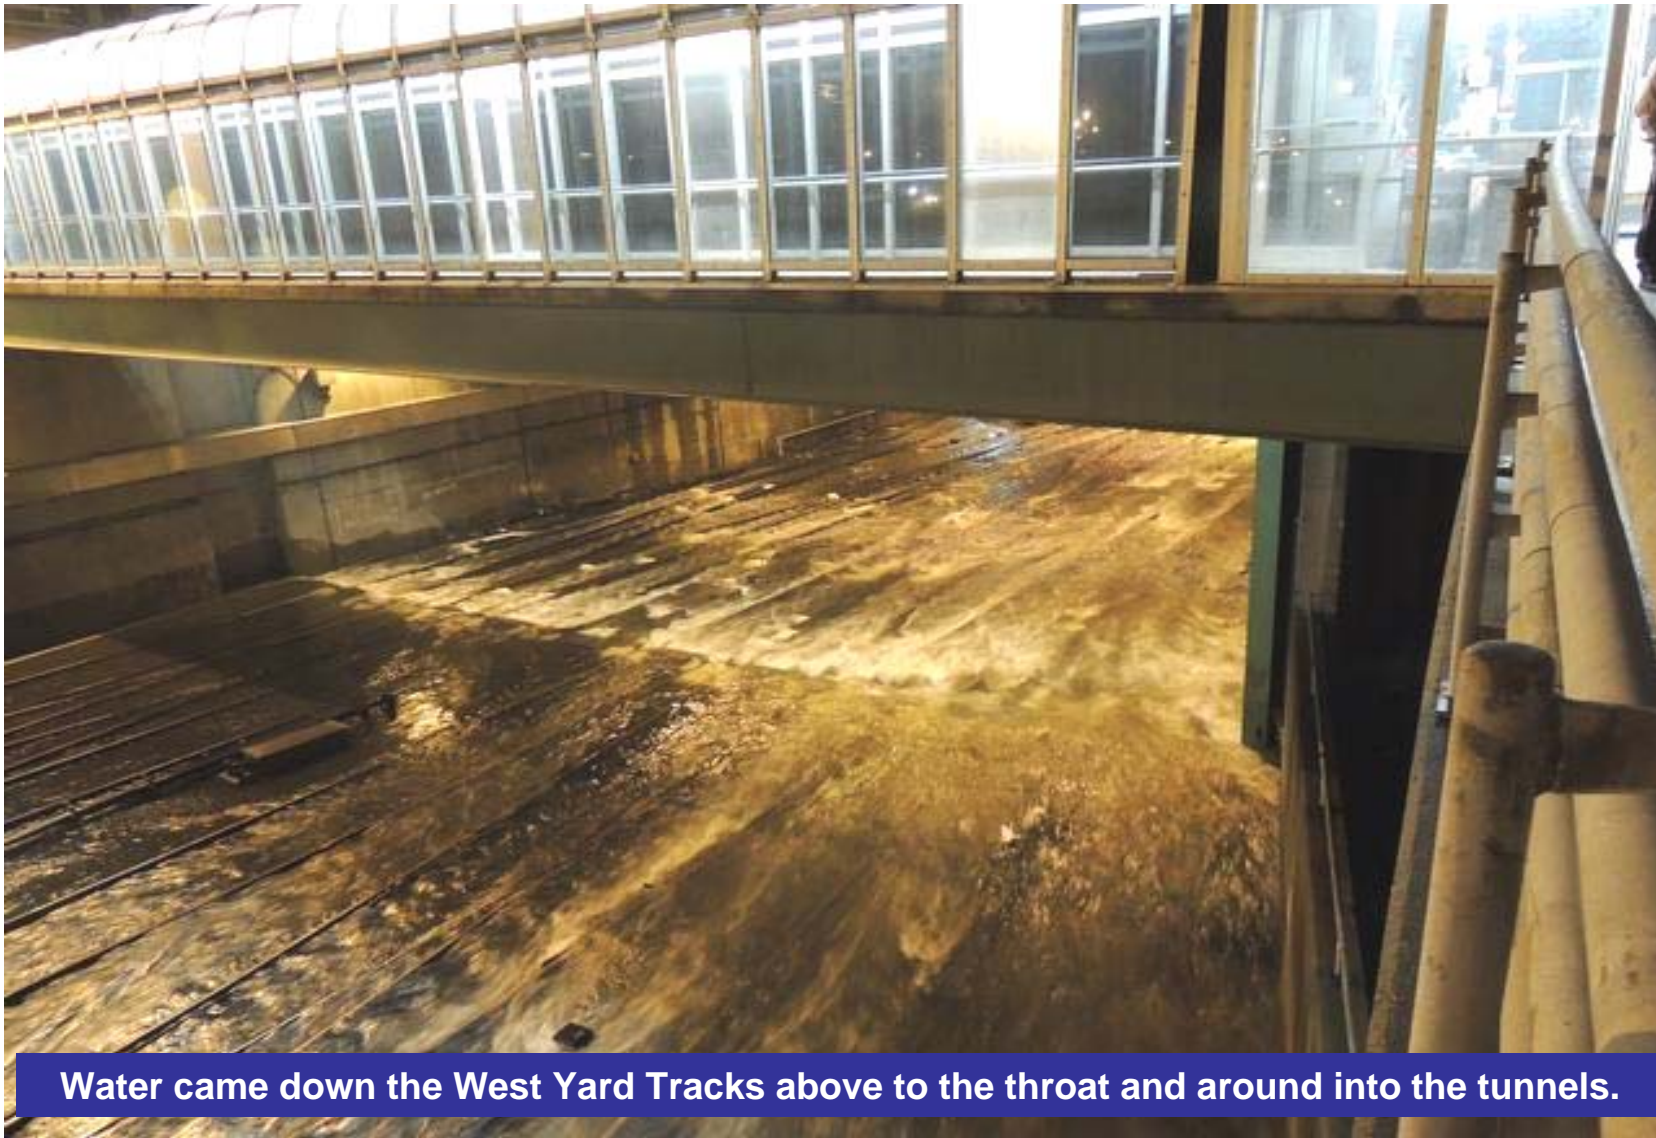
# Water Source That Flooded North River Tunnels

Water came down the West Yard Tracks above to the throat and around into the tunnels.

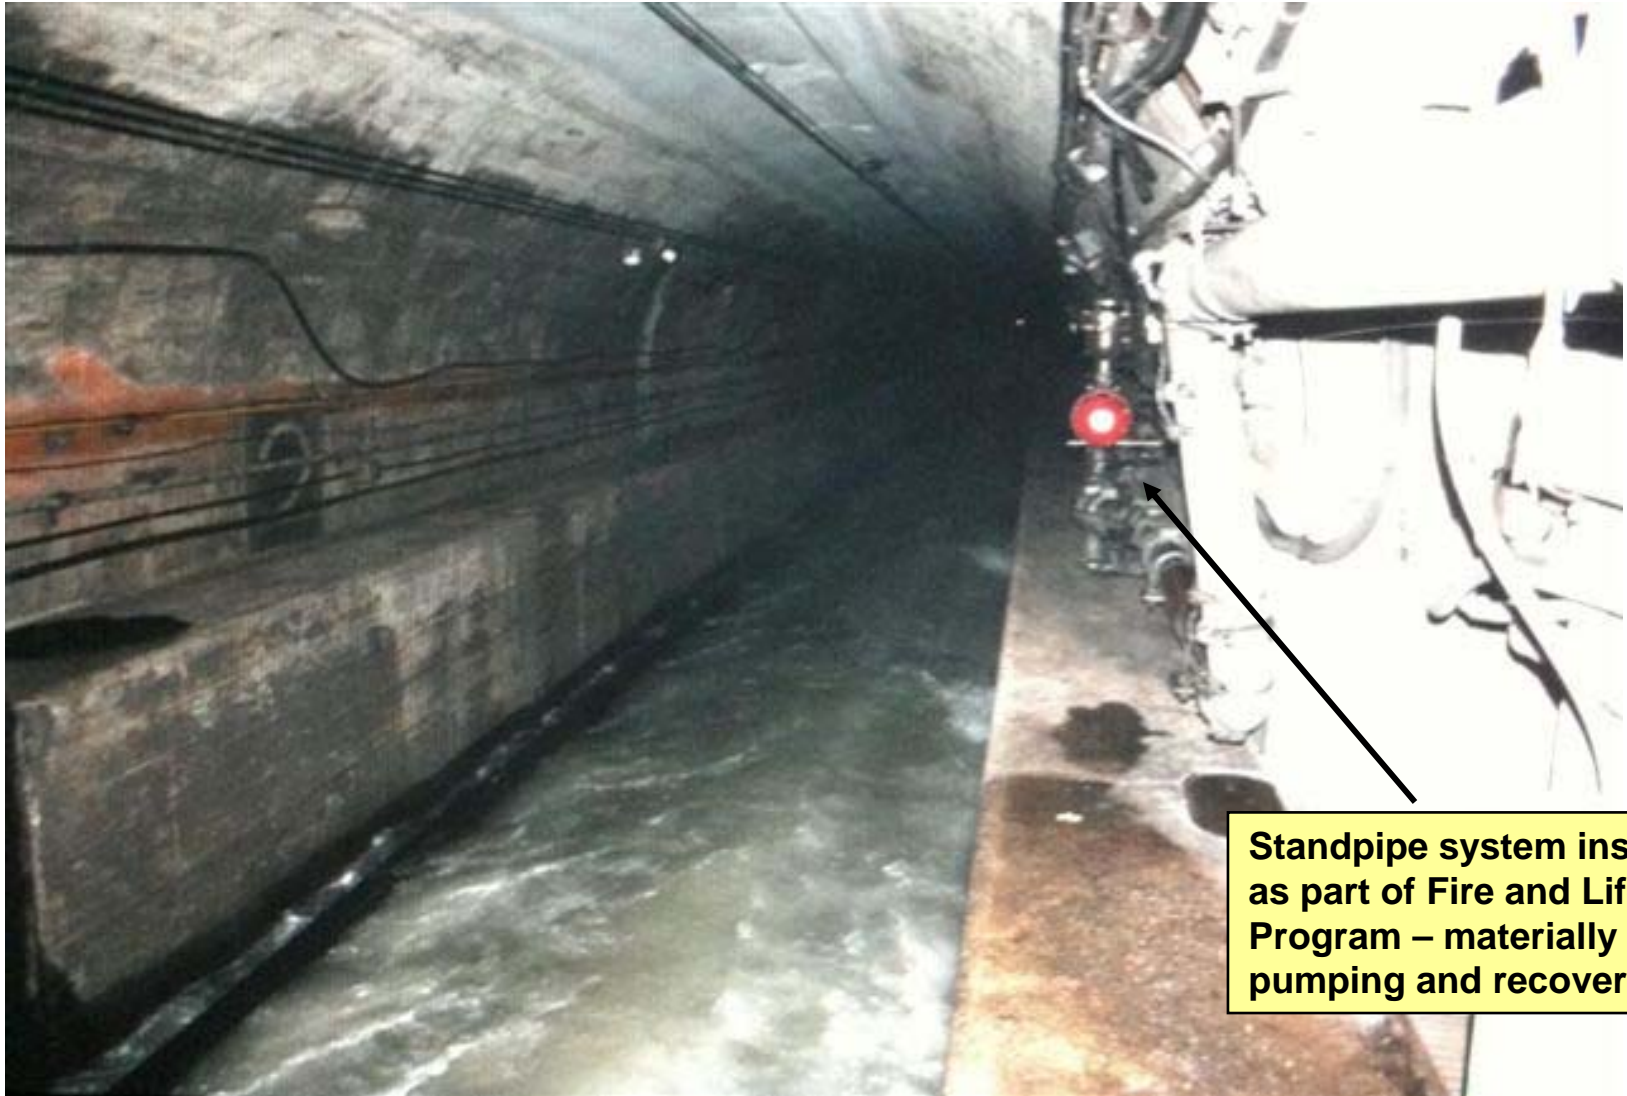
# East River Tunnels Under Water

**Estimated 3.25 Million Gallons of Water**

**Standpipe system installed as part of Fire and Life Safety Program – materially aided pumping and recovery effort**

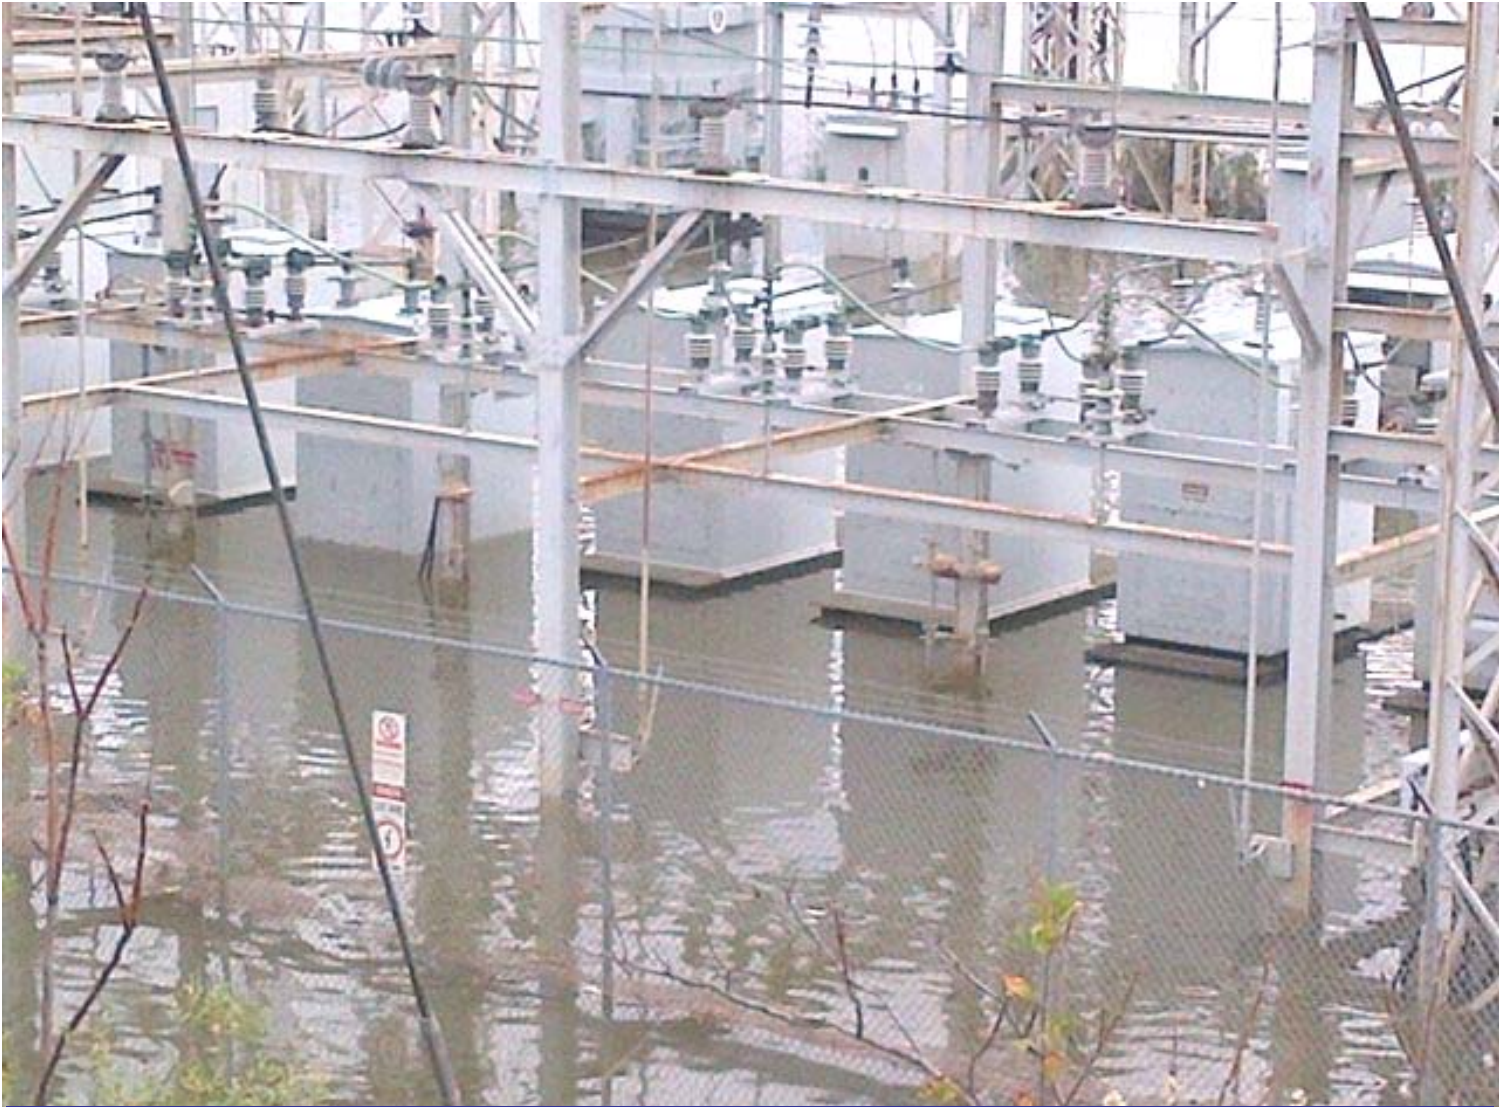
# Kearny Electrical Substation 41 Flooding

Limited traffic between Newark and NYC due to constrained power availability

- **Turn Around Service Washington to Newark – October 31**
- **Tunnel Restoration:**
  - South Tube Restored - November 1
  - East River Tunnel Line 2 Restored – November 10
  - East River Tunnel Line 1 Restored – November 11
  - North Tube Restored – November 12
- **Substation Restoration:**
  - Kearny Substation 41 Restored – November 16

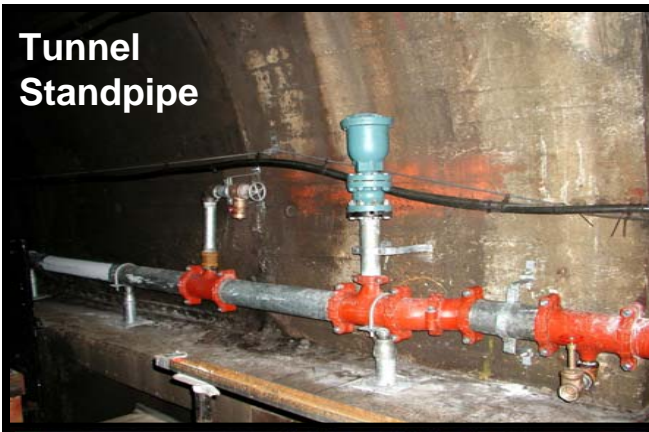
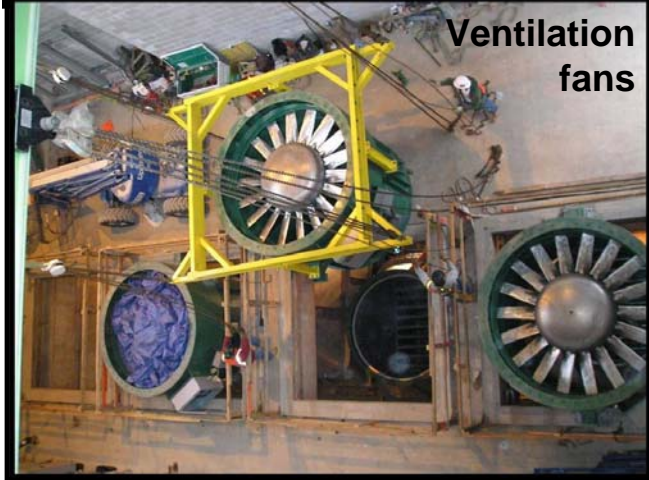
# Previous investment mitigated damage and aided recovery

- Recovery Act funding and annual capital appropriations supported extensive investment in the 2005-2011 timeframe
  - Major improvements to tunnel fire and life safety equipment
  - New ventilation systems
  - Tunnel access improvements
- Over 230 miles of tree removal and clearing since 2008
- Culvert and ditching clearance prevented water accumulation and washouts along roadbed

**These investments minimized damage and speeded system recovery**
